Manhole Inspection Summary

Manhole # S55M__012MH

Insp Date: **6/5/08 8:51 AM**

Location Address: **3610 dillon st**

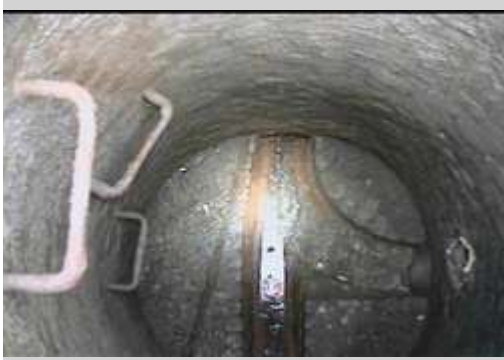
Defect 3

Condition: ☐ Sound ☐ Cracked ☐ Root Intrusion ☐ Deteriorated ☐ Leaks ☒ **Debris**

bench debris

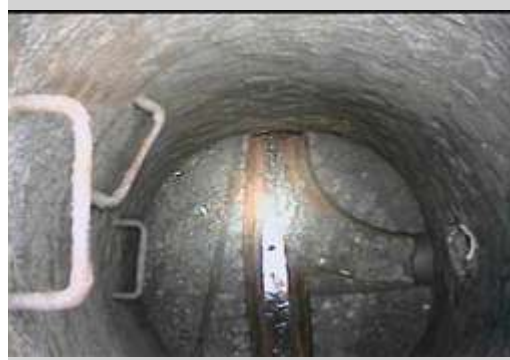
Defect 2

Condition: ☐ Sound ☐ Cracked ☐ Root Intrusion ☐ Deteriorated ☐ Leaks ☒ **Debris**

channel debris

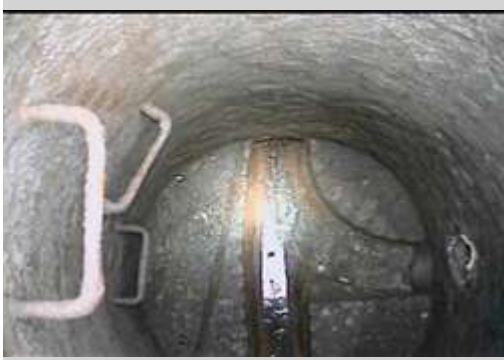
Defect 1

Count: **4** Missing: **0** ☒ **Corroded**

steps

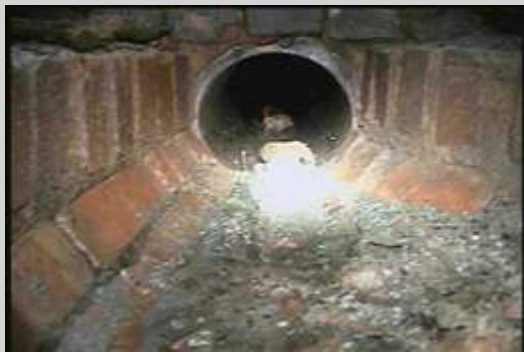
12 O'Clock Outflow

8 in. Circular Gravity Sewer
Pipe Out @ 12 O'Clock

Deposits: ☐ None ☐ Mud ☐ Sludge ☒ Debris ☐ Grease

Silt Depth: 1 (in.) Deposits Extent: Light
